Background

Serving as an arterial road, Reseda Boulevard extends the entire stretch of the San Fernando Valley. This primary Boulevard intersects with two freeways that are approximately six miles away from each other; the Ronald Reagan Fwy (118) to the north and the Ventura Fwy (101) to the south. The selection of the project scope is a 1.5 mile stretch of Reseda Boulevard that runs parallel to the California State University Northridge (CSUN) campus. CSUN is known to be a commuter school with high vehicular congestion around campus, especially on Reseda Boulevard. With cars being the dominant factor at the site, walkability and bikeability is minimal as certain characteristics discourage such activities. Collaborating with the District 12 Councilmember's office, the prospect of this project is to provide recommendations that can encourage walkability and bikeability on Reseda Boulevard.

The purpose of this project was to analyze elements at the site that encourage/discourage individuals to walk and bike. After analyzing the collected data, recommendations (design guidelines) were developed to help promote walkability and bikeability on Reseda Boulevard. These guidelines provide

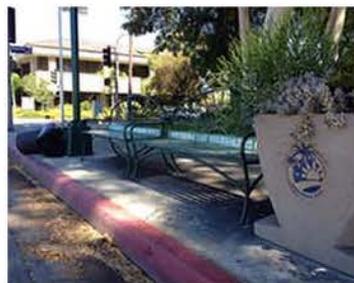
image 1

The site analysis observations confirmed the number one response of worst characteristics which deals with trash and graffiti. Within the 1.5 mile stretch of the site, there are only a total of ten trash cans. From the site observation, many of the trash cans were overflowing with trash which resulted in trash on the sidewalk (image 1). Another issue with the types of trash cans is that the bottom of the can has an opening which allows for the trash liquids to percolate which then stains the sidewalk (image 2).

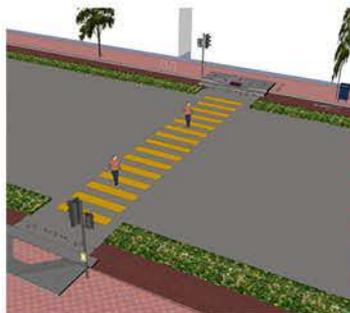
6. crosswalk

In promoting walking and biking, safety is of great concern. One of the biggest findings in this study was the concern people have with regards to traffic. Traffic volume, crosswalk safety, and safety from traffic were all categories in the worst characteristics with percentages of 18%, 9%, 8%, respectively. The safety map illustrates the quantity of traffic accidents which involved pedestrians and cyclists. Traffic accident information was gathered for a five year period (2006-11) from TIMS (Transportation Injury Mapping System) website. Although accidents are reported throughout the site, certain intersections have higher concentrations. The bulk of the accidents occurred on Reseda Boulevard between Plummer and Nordhoff and at the Rayen and Reseda intersection. The Dearborn and Reseda intersection witnessed the highest concentration of pedestrian accidents. This wide intersection had no stoplight until recently which made it very difficult for pedestrians to cross a total of 5 lanes. Fortunately, a streetlight crossing was added at this intersection in 2013 which will help improve the safety of pedestrians. The major concerns for this vehicular arterial road is safety from vehicles and traffic.

Crosswalk Restriping: \$6.00 per Linear Foot
