The Proliferation of *Arundo donax* in Arroyo Las Posas

Geography 490, Spring 2006

California State University, Northridge

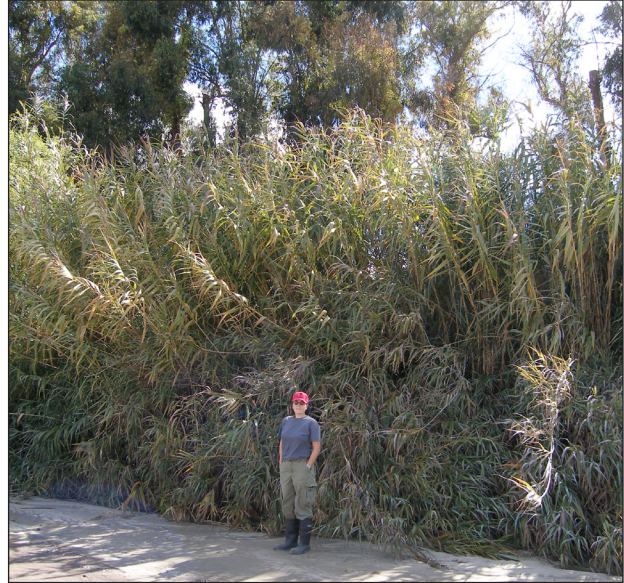
Figure 1: The *arundo* in this image is approximately 5m tall.

Arundo is a perennial, giant grass (Poaceae) that grows 2.75 m to 9 m tall (Dudley 2000) (Fig.1). Under optimum conditions, *arundo* can grow up to 6.3 cm day⁻¹ (Rieger and Kreager 1989). It is reed or bamboo-like in structure. It has hollow, segmented stalks (culms) 1 to 4 cm in diameter that grow

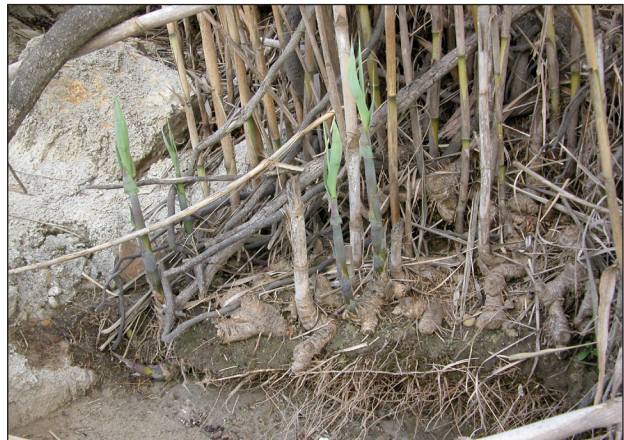
Figure 2: *Arundo* rhizomes and sprouts.

Arundo spreads by vegetative reproduction – as seeds in North American environments appear to not be viable – either by sprouting from stem sections or rhizome pieces (Fig.2), or extension of underground rhizomes (Else 1996, Dudley 2000). *Arundo* spreads to greater extents when rhizomes are carried downstream by flood waters (Else 1996, Boose and Holt 1998, Dudley 2000) (Fig. 3). If *arundo* stalks are cut or otherwise removed from the main plant, the release of new basal stems is triggered (Frandsen 1997).

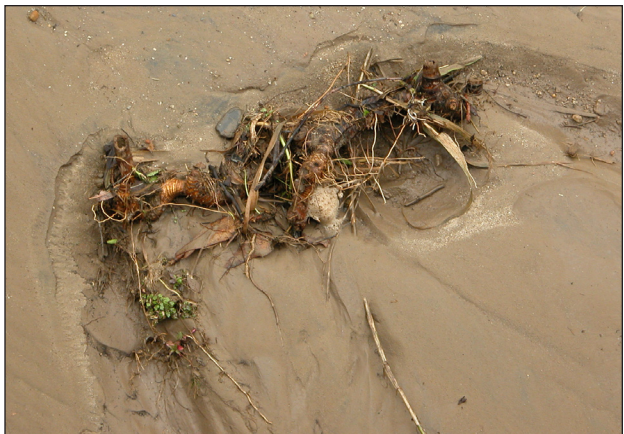
Figure 3: Dislodged and partially buried piece of *arundo* rhizome. Section is approximately 45 cm in length.

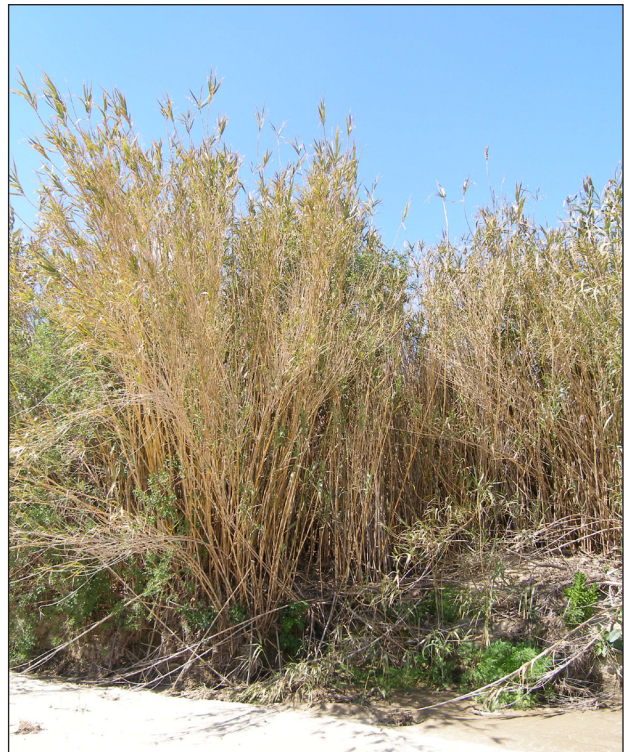
Figure 4: Arundo lacks structural diversity necessary for nesting birds and is too dense to fly into and through.

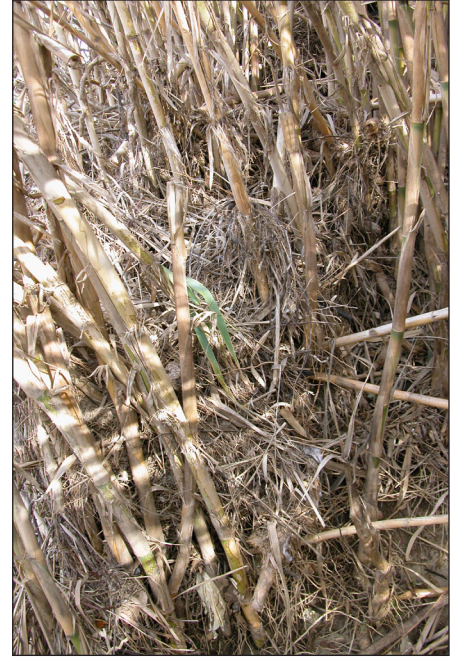
Figure 5: Arundo processes excessive amounts of dry detritus.

states create natural fire breaks. However, once colonized by arundo, they serve as conduits and further spread fire. Arundo produces copious amounts of dry detritus (Fig. 5), which has been estimated to more than double the available fuel for wildfires (Scott 1994). Arundo's flammability introduces fire into riparian environments on a more frequent basis. When increased fire frequency is coupled with arundo's fast growth rate, indigenous species are eventually eliminated owing to their slower rates of growth and recovery, which converts the vegetation of typical riparian systems to an arundo monoculture (Bell 1993).

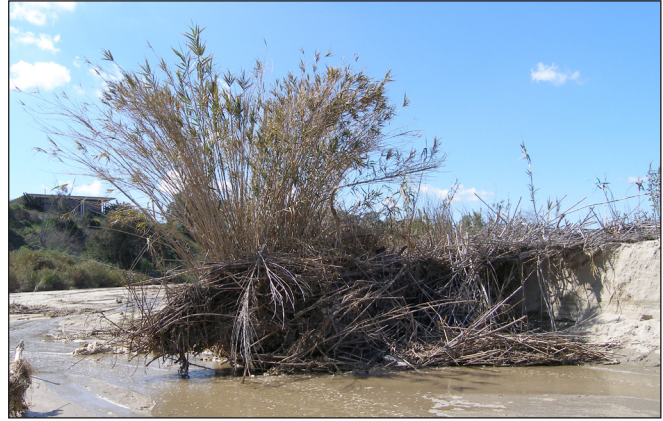
Figure 6: An arundo stand in the process of being undercut.

Owing to the dense manner in which it grows, arundo also contributes to flooding and erosion. Erosion is triggered by obstructions that redirect flow and increase scouring (Tabacchi *et al.* 2000; Steiger *et al.* 2003; Merritt and Cooper 2000; Graf 1978, 1982; Bendix and Hupp 2000; Tooth and Nanson 2000). Arundo not only impedes flow (Robbins *et al.* 1951), but forms channel obstacles as it is easily undercut during periods of heavy flow because its root system lacks the depth of native vegetation (Dudley 2000) (Fig. 6). Flooding and overbank flow result from reductions in channel carrying capacity. Arundo traps larger amounts of sediment than native riparian vegetation, which decreases channel size (Frandsen and Jackson 1993) and alters flow regime (Bell 1997) (Fig. 7).

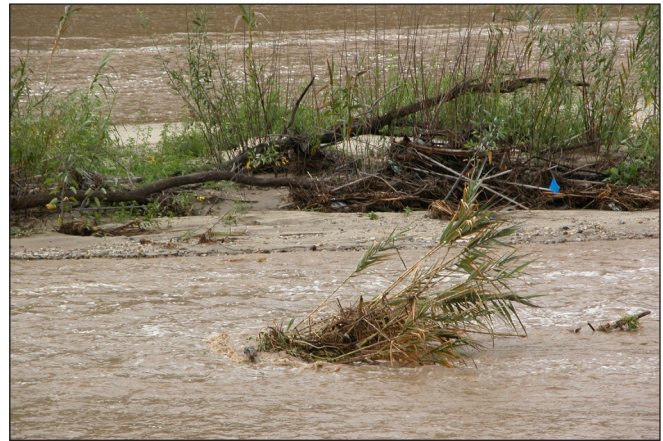
Figure 7: An arundo island (background) created as a result of arundo's ability to trap sediment.

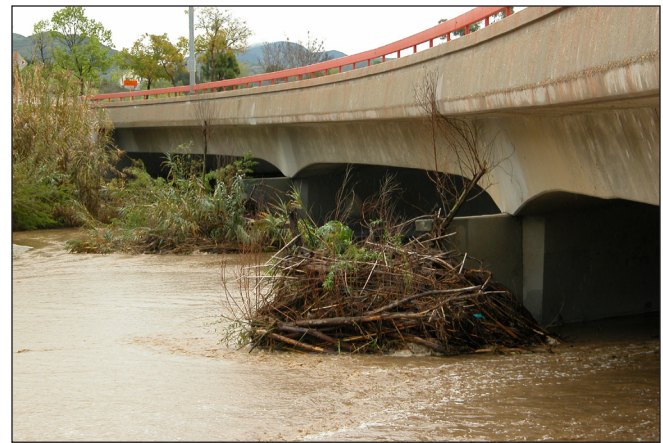
Figure 8: Arundo accumulations on Upland Road bridge in Camarillo. Some of this uprooted biomass is beginning to sprout.

The density of arundo biomass also creates debris dams as it becomes tangled among itself and also traps other floating debris. Debris dams can damage bridge pilings (Fig. 8) and other physical

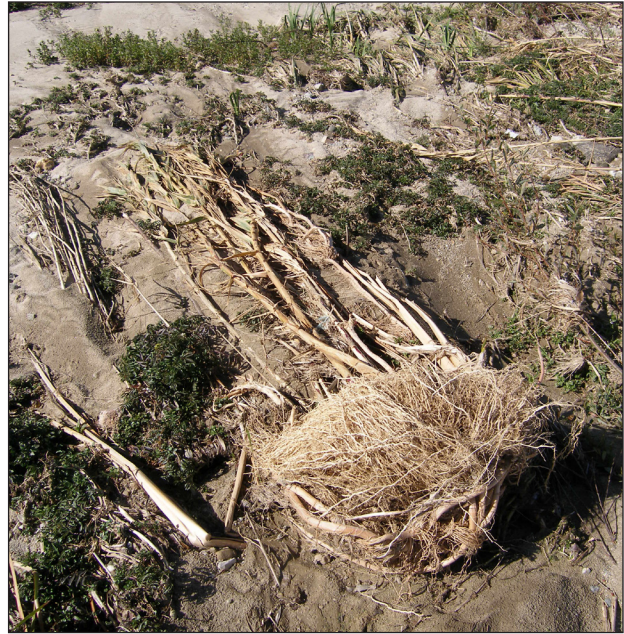
Figure 9: An uprooted clump of arundo that was deposited on an upper channel terrace during a high flow event.

downstream via water flow (Else 1996, Bell 1997, Boose and Holt 1998) (Figs. 9 and 10). Rhizome fragments can sprout after being severed from the parent plant for over 4 months (Boose and Holt 1998), and after having been buried at depths of 100 cm (Else 1996). This is due in part to the greater soil moisture availability at depth, and also because rhizome and stem segments of arundo store greater amounts of energy than the seeds of native species (Else 1996). Thus, in areas where arundo is present, its high growth rate and vegetative manner of reproduction allow rapid colonization of disturbed areas, enabling it to achieve dominance in many riparian ecosystems (Dudley and Collins 1995, Bell 1997).

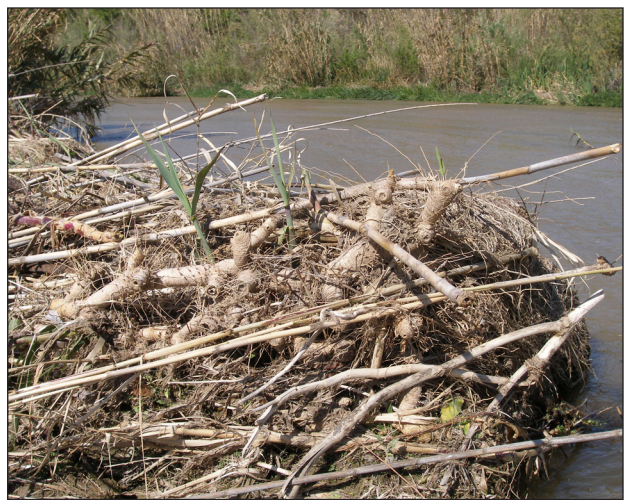
Figure 10: An uprooted clump of arundo that has started to sprout.

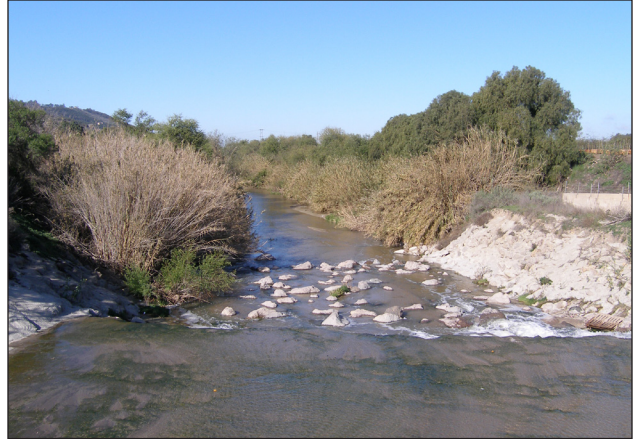
Figure 12: The upstream boundary of the study area.

Ventura County is situated along the coast of southern California, between Santa Barbara and Los Angeles Counties. The specific area of investigation is bounded by Hitch Boulevard near the western boundary of the city of Moorpark (Fig. 12), and Upland Road near the northern boundary of the city of Camarillo (Fig. 13).

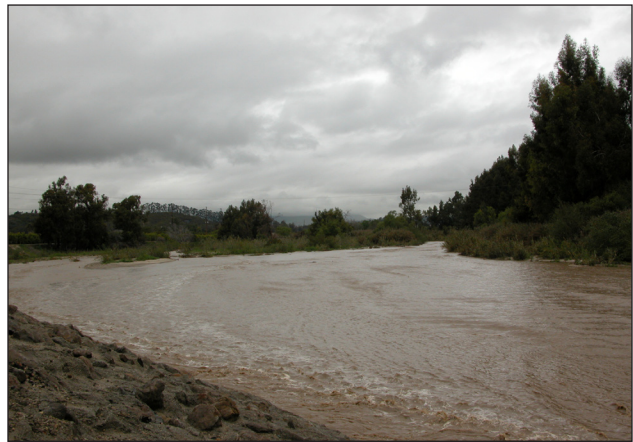
Figure 13: The downstream boundary of the study area.

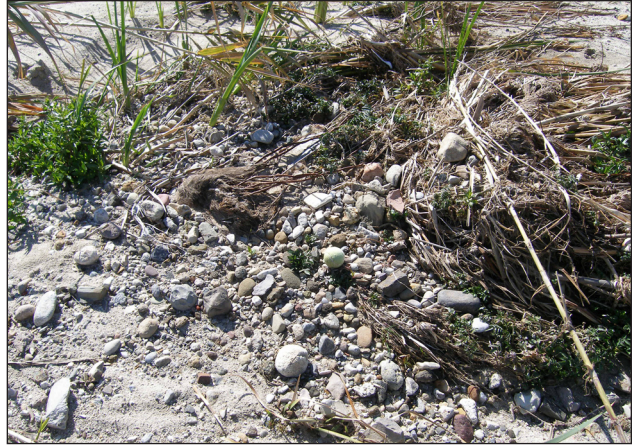
Figure 15: Typical bed materials found within the channel.

alluvial sediments which range from fine silt and sand to small cobbles (Fig. 15). The stream is channelized upstream of the study area for a distance of 5.72 km, but the stretch discussed in this report is unconstrained (Figs. 16 and 17).

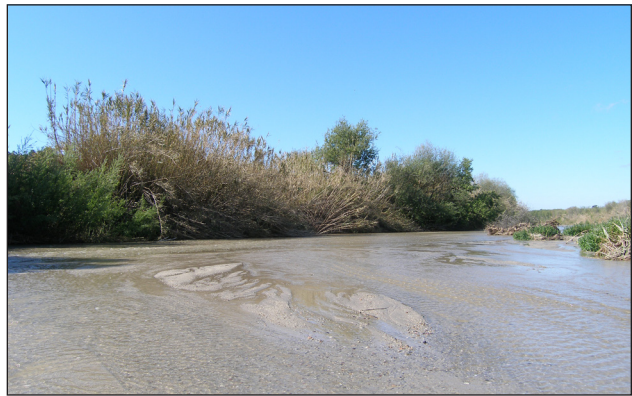
Figure 16: A view near the middle of the study area.

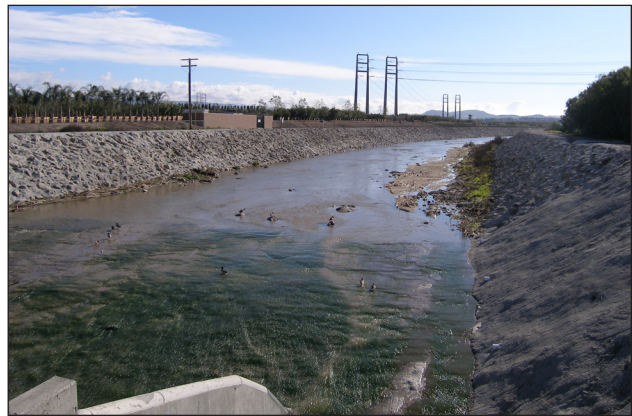
Figure 17: Upstream of the study area.

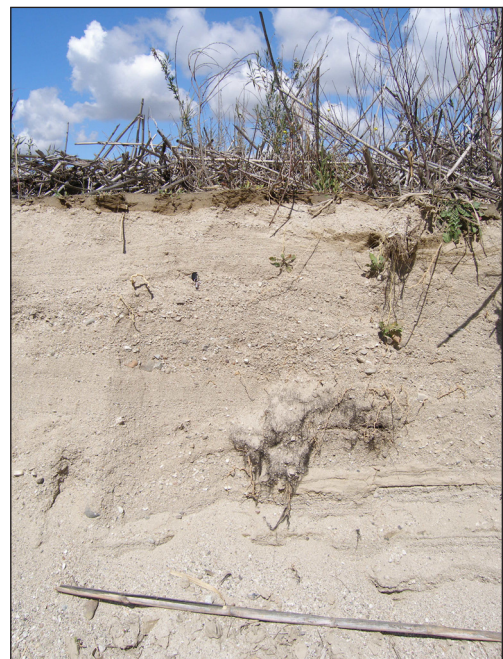
Figure 18: A section of channel bank from within the study area. Sand is the primary component.

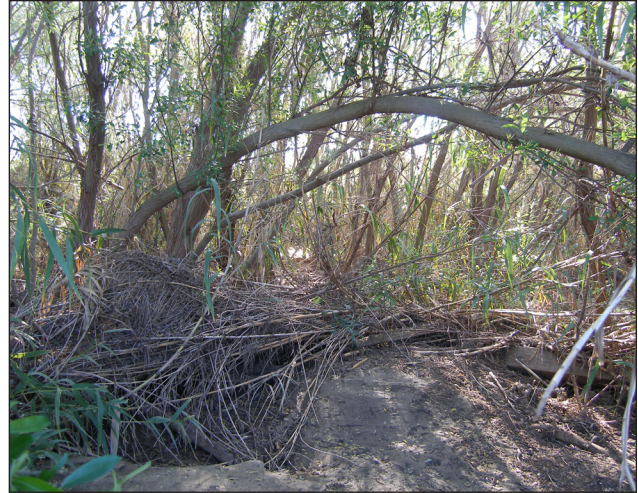
Figure 19: Arundo is mixed in with native willow populations. A debris dam consisting primarily of arundo stalks is lodged against the willow trunks.

Arundo outcompetes native vegetation, and is the principal species in many of the riparian areas within the watershed. Native riparian vegetation has an open, multi-storey nature that is well-adapted to flood events, but the dense growth habit of arundo has transformed riparian areas into impenetrable thickets of vegetation that impede water flow during high flow events, increase fire hazard, and are unusable to native species as habitat. In the study area, arundo occurs in some places as dense monocultures, and is intermixed with native vegetation in others (Fig. 19).

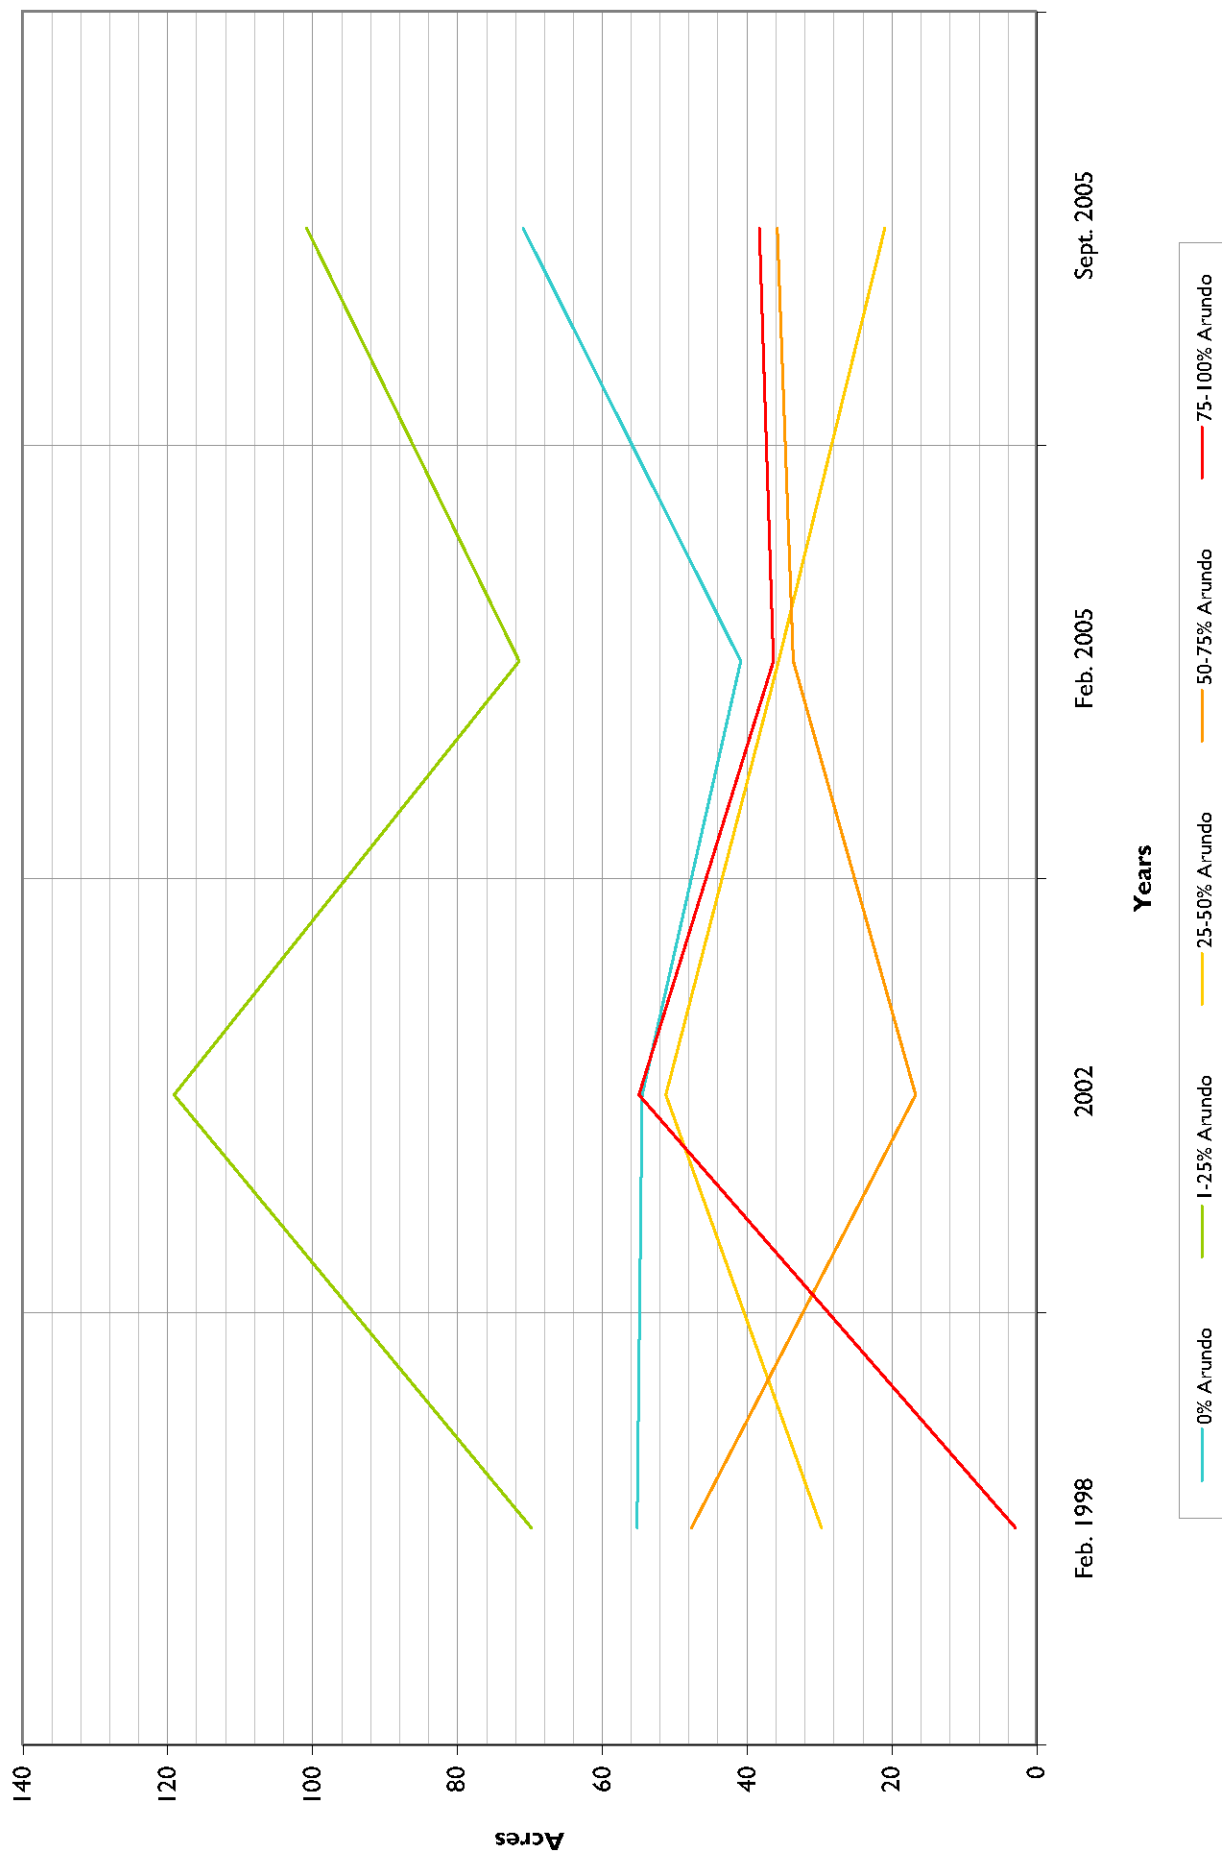
Figure 32: Acres of Arundo

areas according to percent of arundo was also performed for images from 1998 through 2005. The images for 1998 show that arundo was present in the channel (Fig. 27), but only established in high density in limited areas (Table 9). The imagery from 2002 indicates that the density of arundo had undergone a significant increase since 1998 (Fig. 28), with the extent of the highest density areas increasing by approximately twenty fold (Table 10). In February 2005, the overall presence of arundo declined (Fig. 29), however it still occupied approximately half of the mapping area (Table 11). By September 2005, vegetation areas had again expanded (Fig. 30), with associated increases in percent arundo (Table 12). Figure 31 shows the change in percentages of arundo during the study period, while Figure 32 shows the change in size of combined arundo percentage groups compared to the total area mapped.

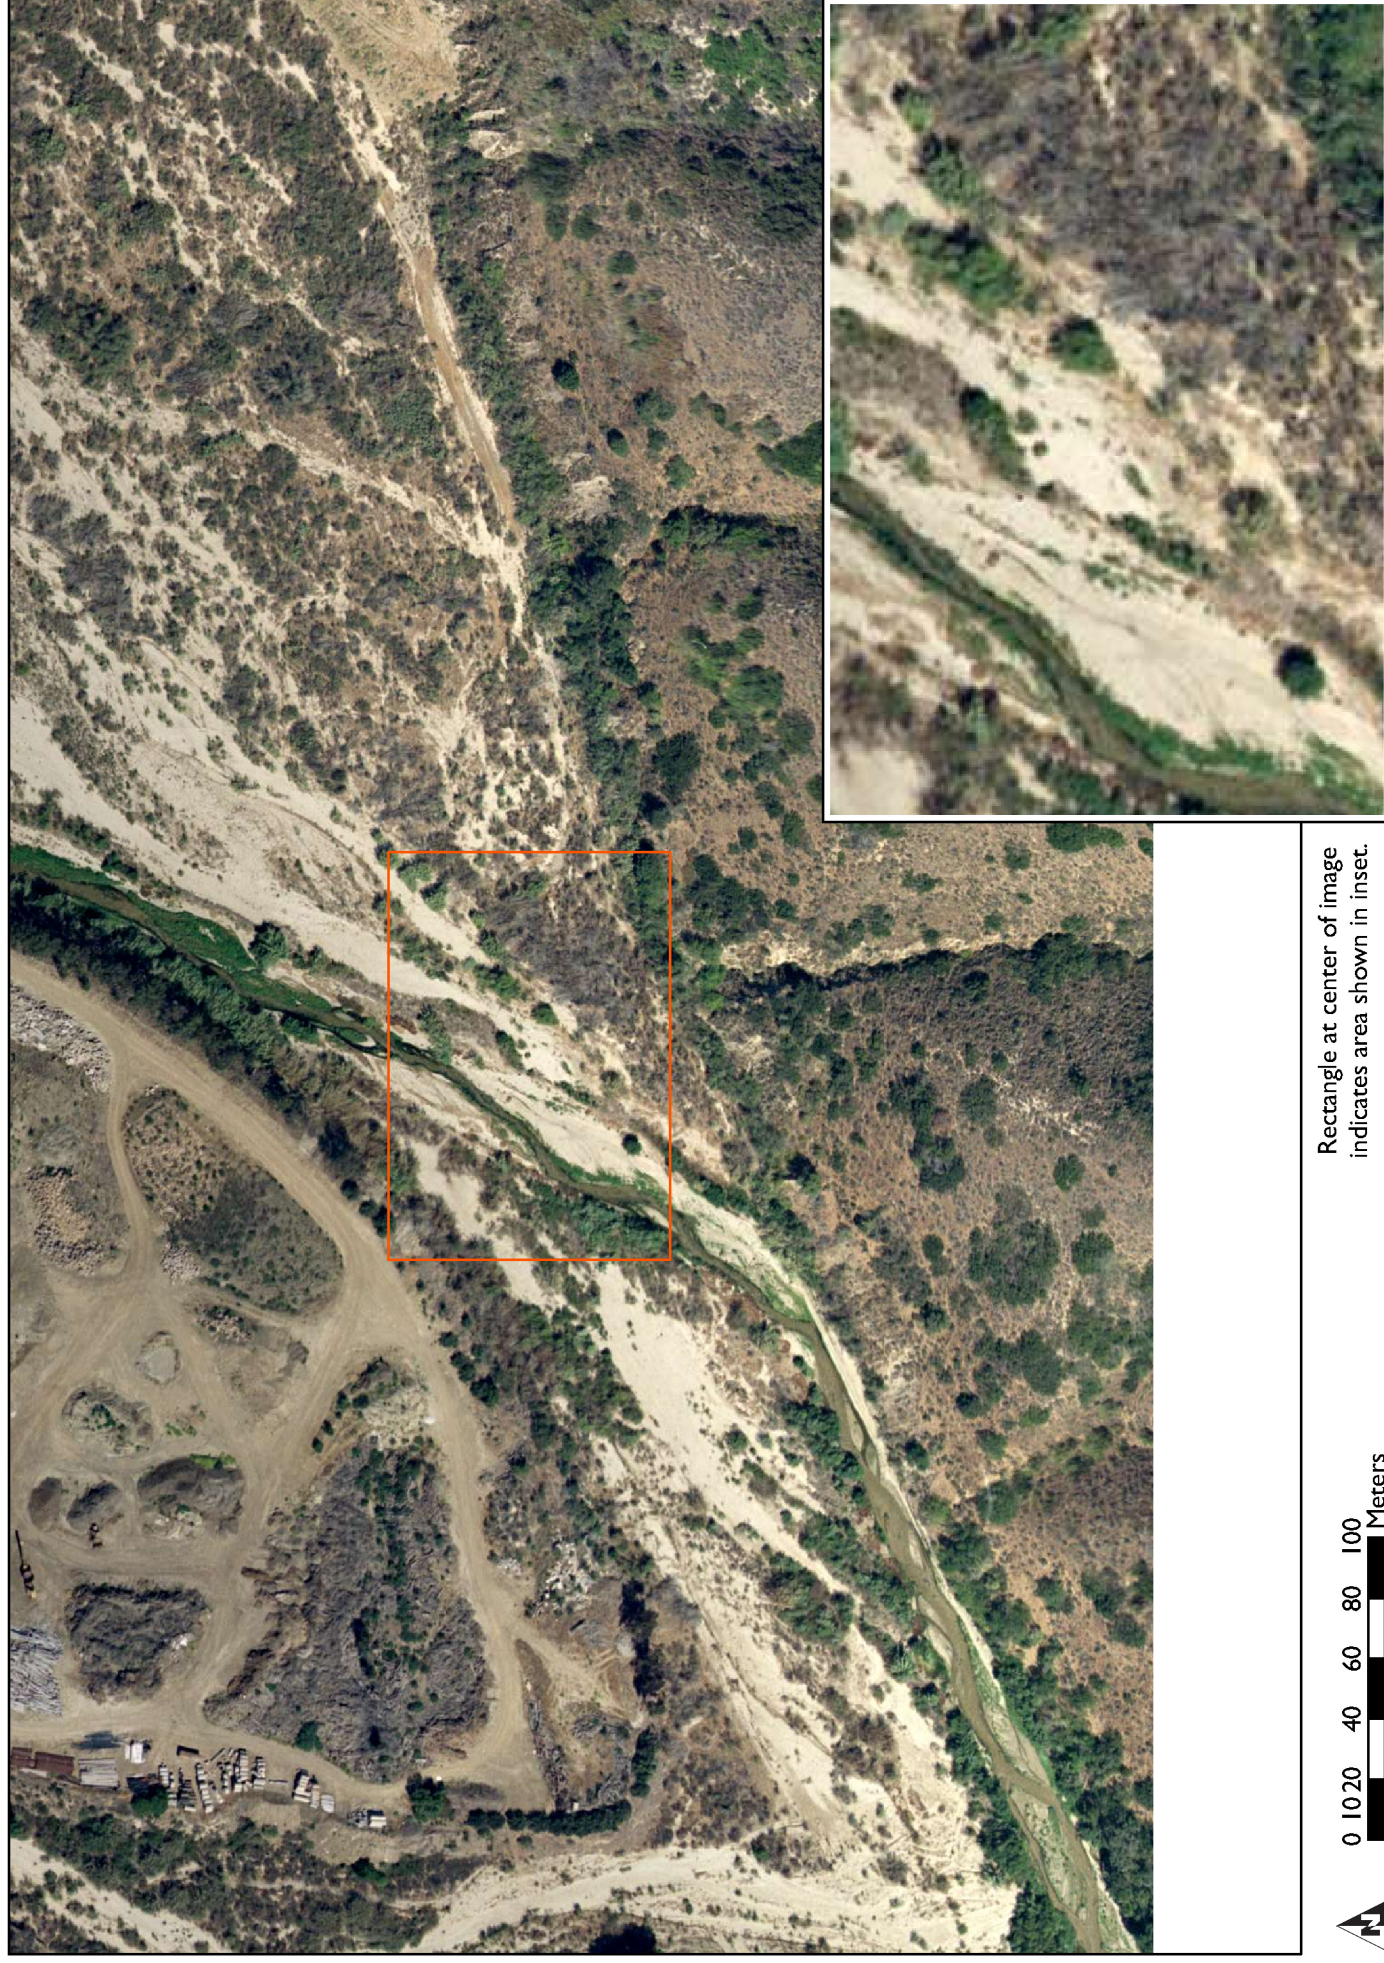
Plate 5: Example Section, Feb. 2005 Aerial Base Map

The magnification of the inset image approximates that at which actual delineation of vegetation types occurred (1:1000).
