CITY OF SAN FERNANDO

Design Guidelines for a Walkable and Bikeable First Street

May 2013

Community Based Urban Design Course
Department of Urban Studies and Planning
California State University, Northridge

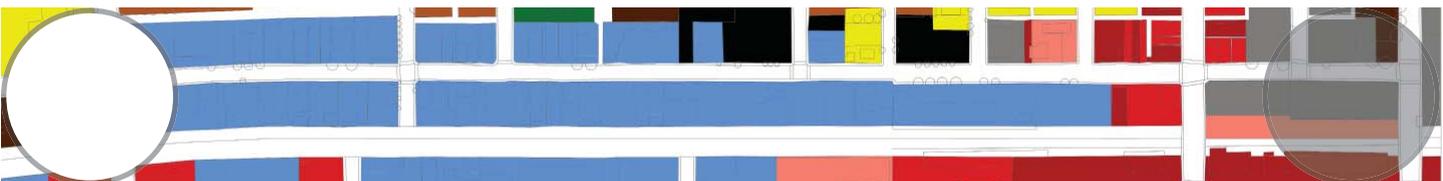
LAND USE MAP

The purpose of this project was to develop recommendations in order to improve the connection between the transit station, Sylmar Metrolink station and San Fernando's Civic Center by making First Street Corridor more walkable and bikeable. The land use map shows industrial and commercial uses along First Street with highlighted Transit Center at the intersection of Hubbard Boulevard and highlighted Civic Center at the intersection of Macneil Street. For this purpose, different elements that constitute walkability and bikeability were analyzed and a set of recommendations were prepared for First Street Corridor.

Single Family Housing	Yellow
Multi-Family Housing	Brown
Office	Orange
Other Commercial	Red
Food Related Commercial	Dark Red
Light Industrial	Blue
Public Entities	Grey
Parks	Green
Parking / Garage	Dark Brown
Empty Lots	Black

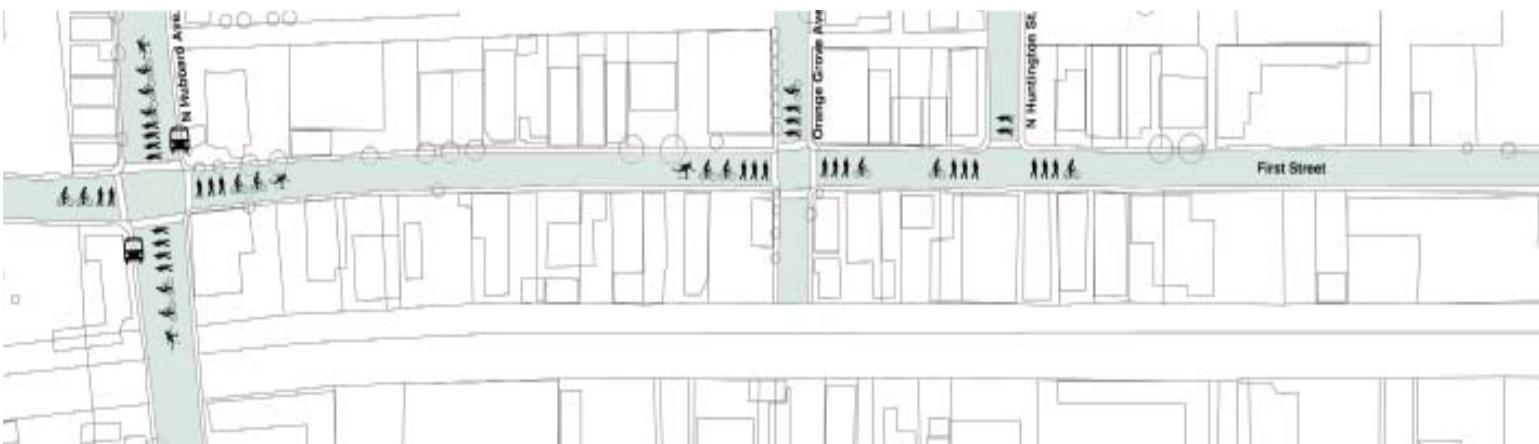
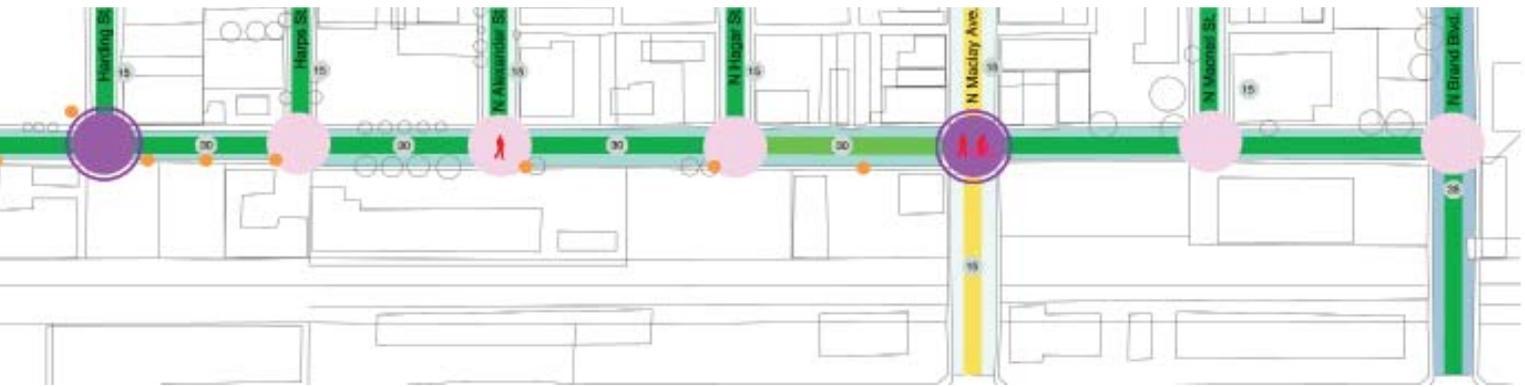
SAFETY MAP

Safety is a critical component for First Street Corridor to be more walkable and bikeable. In order to assess the safety component on First Street Corridor a safety map and a circulation map were prepared in addition to conducting questionnaires about the best and worst characteristics of streets and sidewalks in the area. The safety map shows speed limits, traffic accidents, traffic volume, crosswalks, traffic lights, and street lights. The circulation map shows the volume of pedestrians, cyclists, skateboarders, and transit users.

However, there is room for improvement for safety on First Street Corridor. One area for improvement includes crosswalks. Some of the crosswalk markings are fading or non-existent. Also, all traffic accidents involving pedestrians or cyclists in the past five years happened at the intersections along First Street Corridor. Accordingly, 11.7% of the respondents found it unsafe to cross streets in the area.

Moreover, despite the positive observations of traffic volume and speed limits on First Street Corridor, 16.6% of the respondents found those to be problematic in the area. The location of the street lights only on one side of the street is also problematic as 17.7% of the respondents identified missing street lights as one of the worst characteristics of the area.

- Speed Limit Sign in Mph 15
- Speed Limit Sign in Mph 30
- Speed Limit Sign in Mph 35
- Pedestrian Accident
- Cyclist Accident
- 0-100 Cars per 30 Minutes
- 100-150 Cars per 30 Minutes
- 850-950 Cars per 30 Minutes
- 900-1000 Cars per 30 Minutes
- Stop Signs Only
- Traffic Lights Only
- Traffic Lights and Crosswalks
- Street Lights

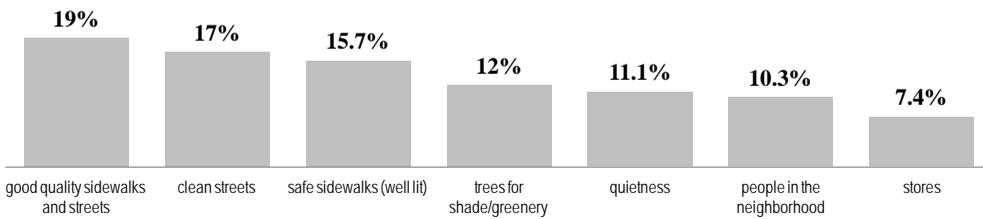
Best characteristics of streets and sidewalks
(Number of respondents: 563)

First Street Corridor has existing components that foster safety. According to the questionnaire outcomes, 10.3% of the respondents found one of the positive aspects of First Street corridor to be the people in their neighborhood, developing a sense of community. This characteristic aligns with observations of a high number of pedestrians, cyclists, skateboarders, and transit users on First Street Corridor.

Many of the respondents (15.7%) also found the sidewalks safe due to good lighting at night. In terms of traffic safety, observations showed a low volume of traffic and low speed limits on First Street Corridor.

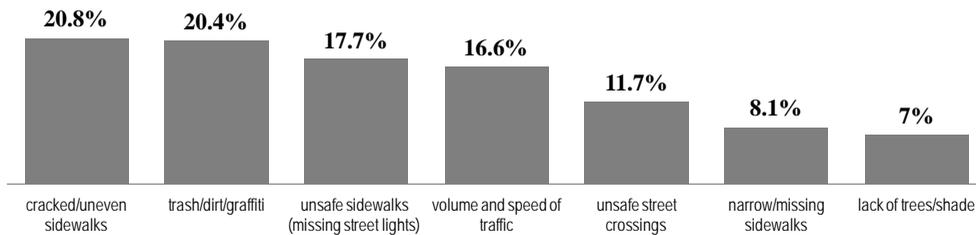
Worst characteristics of streets and sidewalks
(Number of respondents: 530)

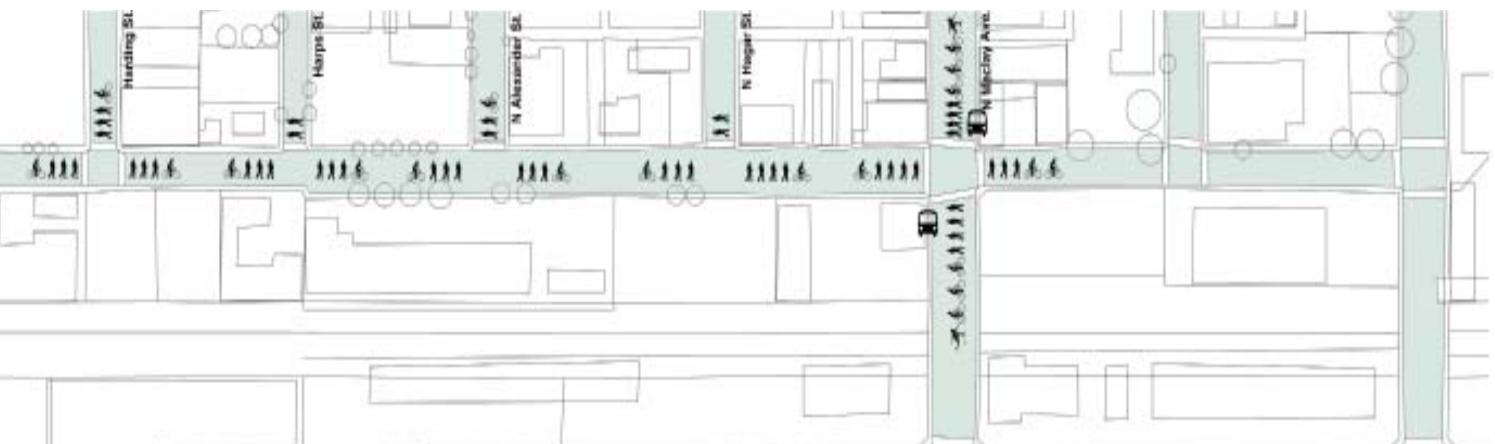
CIRCULATION MAP

- Each = 5 pedestrians
- Each = 5 cyclists
- Each = 5 skateboarders
- Each = 5 transit riders

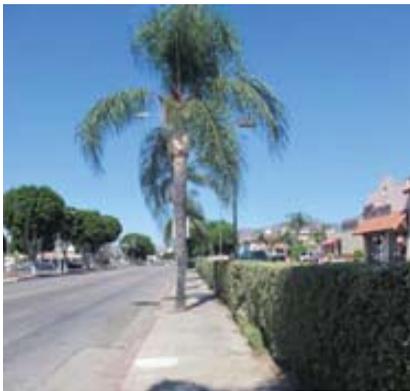
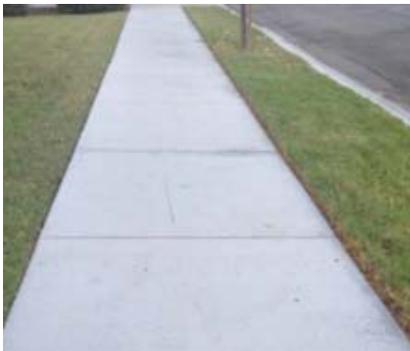
One of the most positive aspects of the streets and sidewalks in the area is also one of the worst: surface quality of sidewalks. The questionnaire outcomes show that 19% of the respondents found the maintenance of sidewalks and streets as one of the best characteristics. However, 20.8% found cracked and uneven sidewalks to be one of the worst characteristics. First Street Corridor reflects this duality with most of the sidewalks having good surface quality and some being problematic. Similarly, 17% of the questionnaire respondents found streets clean, while 20.4% complained about trash, dirt and graffiti. The accessibility map shows only a small section of First Street Corridor presenting cleanliness related problems.

According to the accessibility map the majority of sidewalks on First Street Corridor have five feet or more of paved width. Some sidewalks have obstacles (poles and trees) making the passable width on the sidewalk less than five feet. The questionnaire outcomes show that there are missing sidewalks in the area, mentioned by 8.1% of the respondents, although First Street Corridor does not have a missing sidewalk.

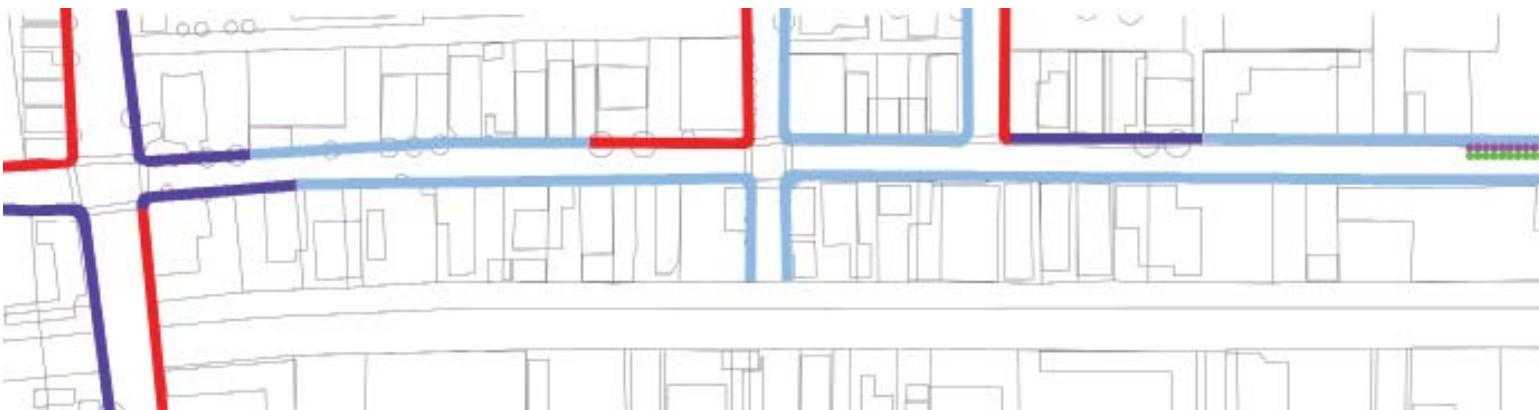
ACCESSIBILITY MAP

Having a high degree of pedestrian and bicycle accessibility is a pivotal aspect of connectivity on First Street Corridor. The level of accessibility was assessed through an accessibility map and questionnaires about the best and worst characteristics of streets and sidewalks in the area. The accessibility map includes information on clear width of sidewalks without obstacles, and cleanliness and surface quality of sidewalks.

- Paved Surface 5ft or more with clear width ■
- Paved Surface 5ft or more with no clear width ■
- Paved Surface less than 5ft ■
- Sidewalk quality issue ●●●
- Cleanliness issue ●●●

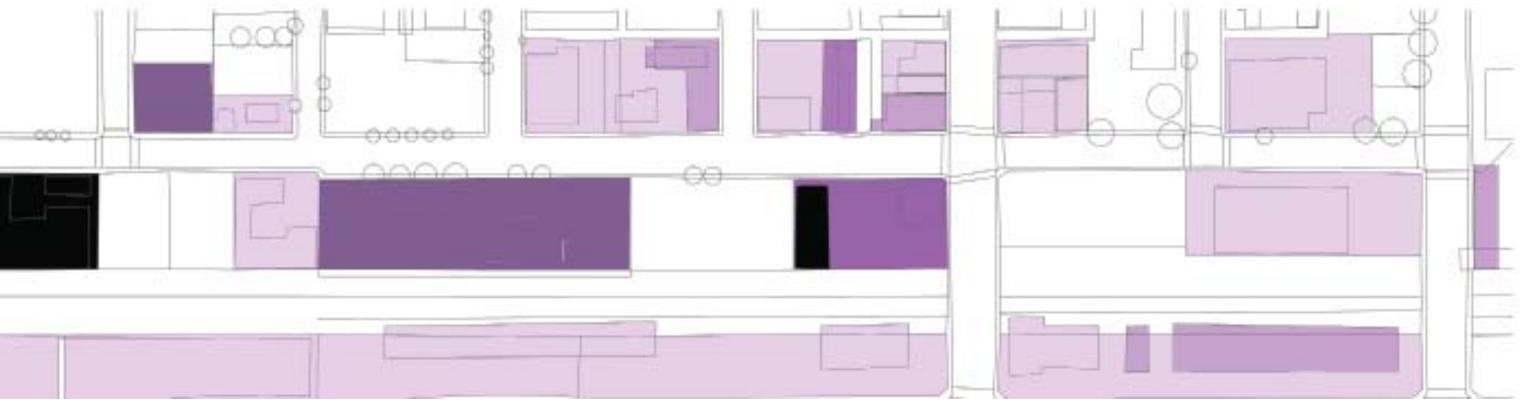
STREETSCAPE MAP

- Windows, Doors & Openings
- Windows & Doors
- Doors
- Windows
- Barred Windows & Doors
- Blind Wall

A walkable and bikeable First Street Corridor also involves aesthetically pleasing features that the pedestrians and cyclists can enjoy. To assess the aesthetics component, a streetscape map with information on the openings of the buildings onto the sidewalks was prepared and questionnaires about the best and worst characteristics of streets and sidewalks in the area were conducted.

The facades of locales are aesthetically unique, giving the area a sense of physical identity. However, the streetscape map shows that some properties have blind walls disconnecting them from the sidewalks. Many of the businesses have a significant amount of windows and doors, but some of those windows and doors are barred or they are painted over preventing visibility. Moreover, some businesses, in addition to having barred windows or doors, have oddly placed entrances away from the sidewalks.

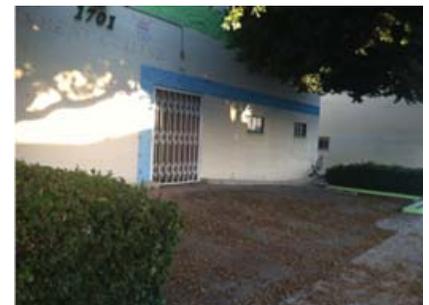
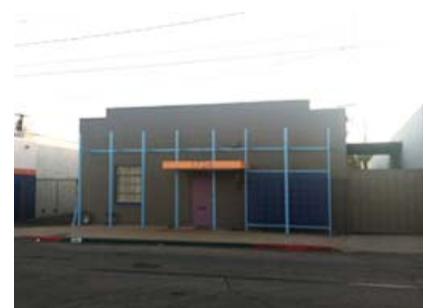
The problem of cleanliness and cracked sidewalk surfaces is related to aesthetics as much as it is to access. First Street Corridor presents some problems related to surface quality and cleanliness, which also make the Corridor less pleasing aesthetically for the pedestrians and cyclists.
