Background

Serving as an arterial road, Reseda Boulevard extends the entire stretch of the San Fernando Valley. This primary Boulevard intersects with two freeways that are approximately six miles away from each other; the Ronald Reagan Fwy (118) to the north and the Ventura Fwy (101) to the south. The selection of the project scope is a 1.5 mile stretch of Reseda Boulevard that runs parallel to the California State University Northridge (CSUN) campus. CSUN is known to be a commuter school with high vehicular congestion around campus, especially on Reseda Boulevard. With cars being the dominant factor at the site, walkability and bikeability is minimal as certain characteristics discourage such activities. Collaborating with the District 12 Councilmember's office, the prospect of this project is to provide recommendations that can encourage walkability and bikeability on Reseda Boulevard.

The purpose of this project was to analyze elements at the site that encourage/discourage individuals to walk and bike. After analyzing the collected data, recommendations (design guidelines) were developed to help promote walkability and bikeability on Reseda Boulevard. These guidelines provide

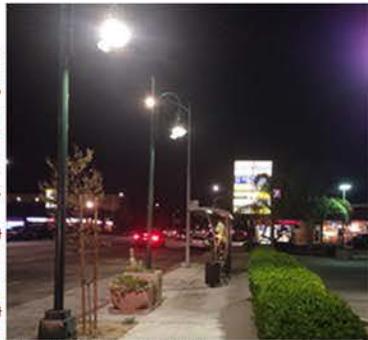
4. shade elements

Although the amount of light is important to feeling safe at night, an abundance of sunlight during the day can make individuals feel uncomfortable. Lack of shade was a concern because 7% of respondents answered that it was one of the worst characteristics. A section of the site provided adequate shade which was between Plummer and Lassen (image 3); mostly residential (land use map). The rest of the site was extremely deficient in trees and forms of providing shade. One form of lack of shade was the absence of coverings for benches. With eight uncovered benches, individuals taking a seat are left exposed to the elements which can get extreme especially in the summertime with temperatures reaching 100+ (streetscape map).

Parklet: \$20,000 per

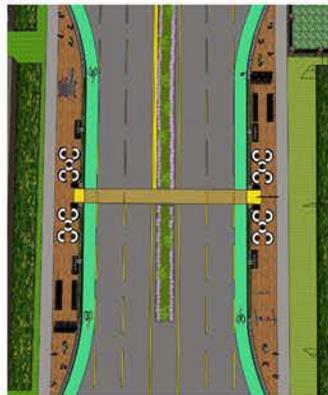
6. crosswalk

In promoting walking and biking, safety is of great concern. One of the biggest findings in this study was the concern people have with regards to traffic. Traffic volume, crosswalk safety, and safety from traffic were all categories in the worst characteristics with percentages of 18%, 9%, 8%, respectively. The safety map illustrates the quantity of traffic accidents which involved pedestrians and cyclists. Traffic accident information was gathered for a five year period (2006-11) from TIMS (Transportation Injury Mapping System) website. Although accidents are reported throughout the site, certain intersections have higher concentrations. The bulk of the accidents occurred on Reseda Boulevard between Plummer and Nordhoff and at the Rayen and Reseda intersection. The Dearborn and Reseda intersection witnessed the highest concentration of pedestrian accidents. This wide intersection had no stoplight until recently which made it very difficult for pedestrians to cross a total of 5 lanes. Fortunately, a streetlight crossing was added at this intersection in 2013 which will help improve the safety of pedestrians. The major concerns for this vehicular arterial road is safety from vehicles and traffic.

5. Maintain streetlights to enhance sense of safety from crime
6. Improve crosswalk safety for pedestrians & cyclists
7. Improve safety from traffic by implementing speed control elements

Crosswalk Restriping: \$6.00 per Linear Foot

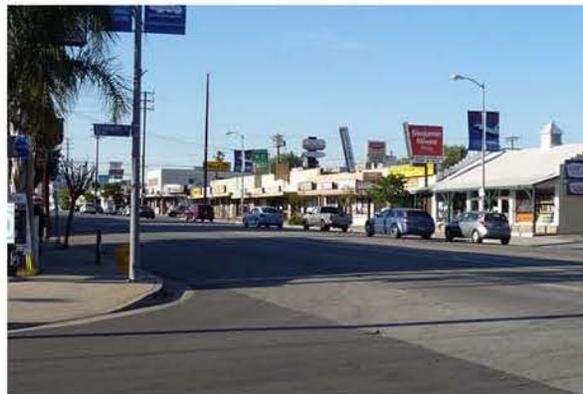
9. land use variety

With one of the highest percentage in the best characteristics category, availability of shops and restaurants was highly regarded. A benefit in this stretch of Reseda Boulevard is that land usage is greatly diversified. With a combination of housing, restaurants, grocery stores, and many others, Reseda Boulevard gives easy access to individuals (land use map). The majority of homes and apartment complexes on Reseda Boulevard are located on the north of the site; a large variation of retail businesses is located directly parallel to CSUN (between Plummer and Nordhoff). In addition to a variety of businesses, a large presence of parking lots is observed throughout the site.

8. Improve surface quality by repairing cracks and uneven sidewalks
9. Sustain the existing land use variety
